▶▶ *Sensor Manufacturer Recommendation for Replacement of Sealing Components on a Schrader TPMS Aluminum Valve Sensor*

Schrader Technical Service Bulletin

Doc. No.: DOP-11-100
Revision Date: April 24, 2013

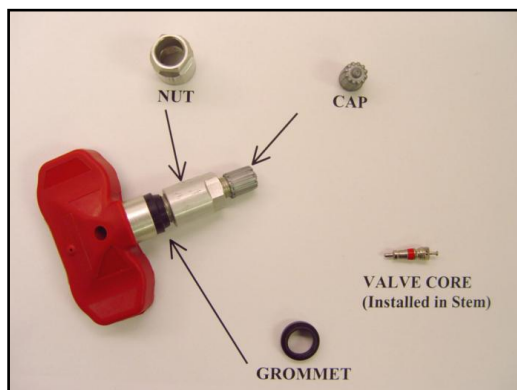
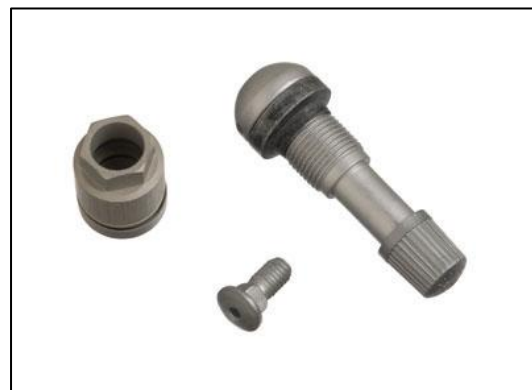
As the sensor manufacturer, Schrader instructs that the sealing components must be replaced when reinstalling a Schrader TPMS aluminum valve sensor, and also when the tire is removed from the wheel, using a genuine OEM validated Schrader TPMS service kit*. Commonly supplied TPMS service kit components are the cap, valve core, aluminum nut & rubber grommet, and may include a replaceable aluminum valve and attachment screw.

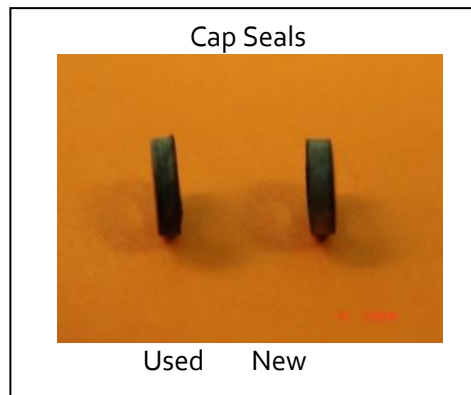
It is also important to use the plastic replacement cap to ensure that a dissimilar metal cap is not used to contact the aluminum stem. Field studies have shown that using a dissimilar metal cap (brass) can cause galvanic corrosion between the cap and the stem, resulting in the cap being stuck to the stem. Use of excessive force, or improper tools, can also damage the cap and or stem.

1. The rubber seal in the original cap will have taken a compression set when subjected to the compressive forces of installation and exposure to changes in temperature over time, potentially degrading the seal and creating a potential leak path for contaminants and moisture to enter the stem.

The cap is the primary seal to the external corrosive environment. The cap contains a rubber seal, which prevents contamination (e.g. salt, abrasives) and moisture (e.g. water, oil, harmful solvents) from entering the stem and contaminating the seal of the valve core, making the cap an integral component in the overall sealing system of the TPMS sensor. Note the use of a sealing grommet in the cap, unlike most passenger car type dust caps.

Note: To install and remove the cap, tighten or loosen by hand, or use the specially designed handle on the OEM approved plastic Cap & Core screwdriver tool. **DO NOT** use any type of metal gripping tool to tighten or loosen the cap.

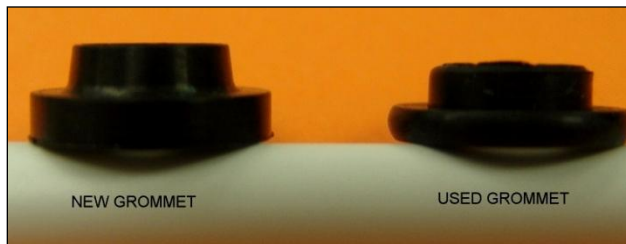
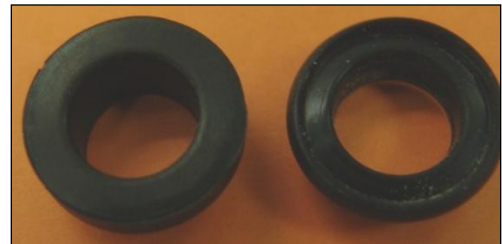
1. The in service grommet will have taken a compression set due to the forces created by the initial torque nut installation. Additional torque to compress the grommet further in order to seal will result in the over torque of the nut and increased compression set on the grommet. Increased torque may damage the nut, damage the stem, or fracture the sensor body.
2. There is a likelihood that the in service grommet will not seat properly with the wheel rim hole or the nut, therefore creating a leak path.

The grommet is the principal sealing gasket between the stem and the wheel rim hole. The grommet is subjected to intense compressive forces and high temperatures over time. The grommet will conform to the mating surface of the rim taking a compression set over time. The grommet, as with any gasket much like a head gasket or a thermostat gasket, is a one-time use only component, and therefore must be replaced whenever it has been disassembled.
