Service Kit components are intended for a one-time use. Schrader recommends that sealing components be replaced every time the tire is removed from the wheel, using a genuine OEM validated Schrader TPMS Service Kit.

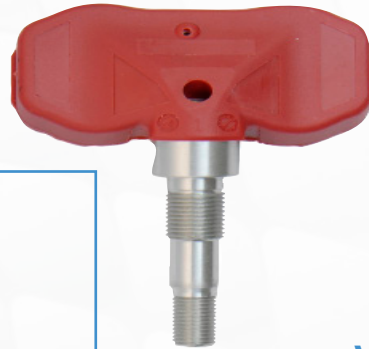
The grommet is the principal sealing gasket between the stem and the wheel rim hole. The grommet is subjected to intense compressive forces and high temperatures, which causes the grommet to conform to the mating surface of the rim, degrading its shape. The grommet will not seal properly if not replaced.

Heat and compressive forces cause deterioration of rubber and plastic components. Replacing the valve core is vital in order to prevent slow leaks.

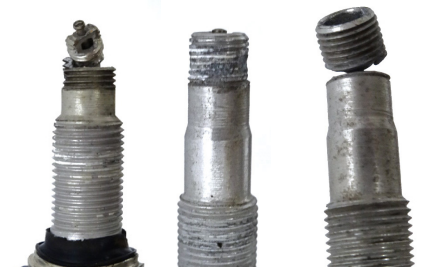
Galvanic Corrosion

Occurs when two dissimilar metals react to each other and cause a deterioration effect. Corrosion in any component prevents accurate assembly during installation.

The nut is made of anodized aluminum to eliminate the contact of two dissimilar metals to prevent galvanic corrosion. Torqueing and re-torqueing the nut can damage the threads to the point of failure. A new nut ensures accurate torqueing.
